**COMPRESSIVE CREEP BEHAVIOR OF NEXTEL™ 720/ALUMINA CERAMIC  
MATRIX COMPOSITE AT 1200°C IN AIR AND IN STEAM ENVIRONMENT**

THESIS

**AIR FORCE INSTITUTE OF TECHNOLOGY**

In Partial Fulfillment of the Requirements for the  
Degree of Master of Science in Aeronautical Engineering

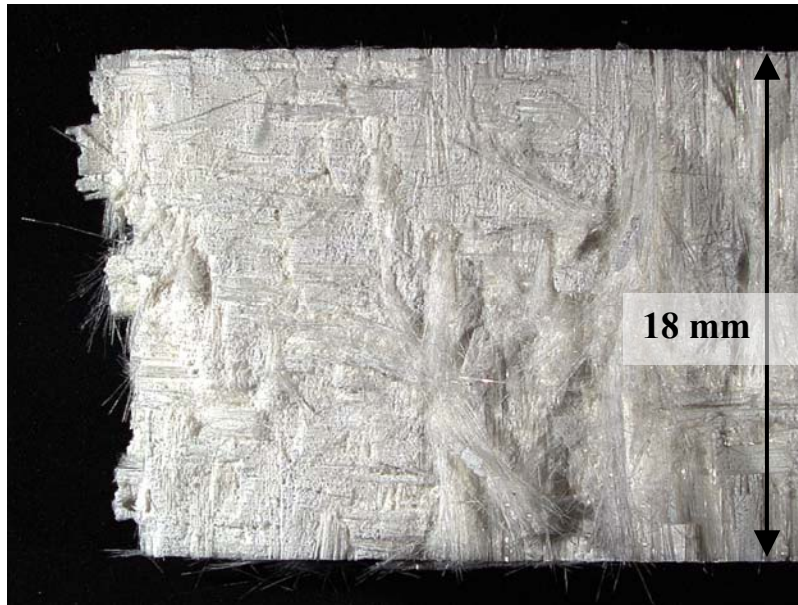
Figure 231. Fracture surface of N720/A specimen tested in compression to failure in air at 1200°C in stress control at -0.0025 MPa/s.

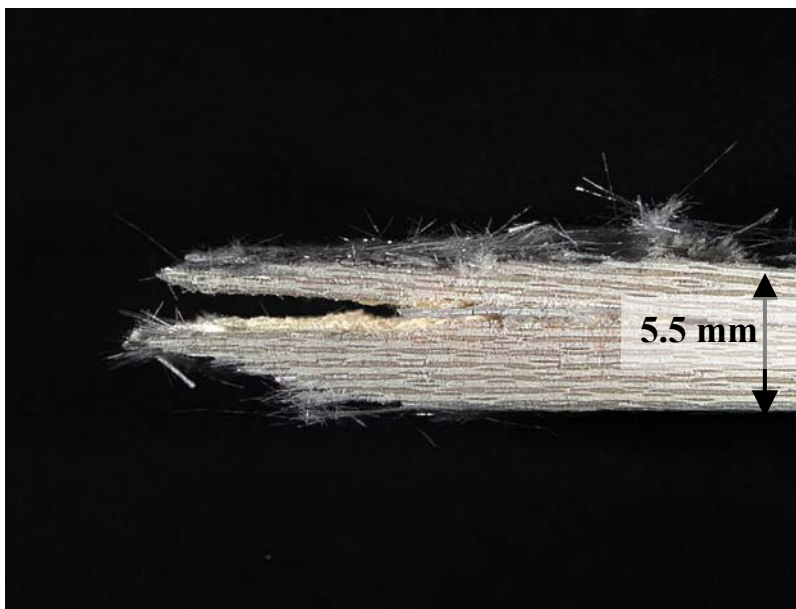
Figure 233. Fracture surface of N720/A specimen tested in compression to failure in air at 1200°C in stress control at -0.0025 MPa/s.

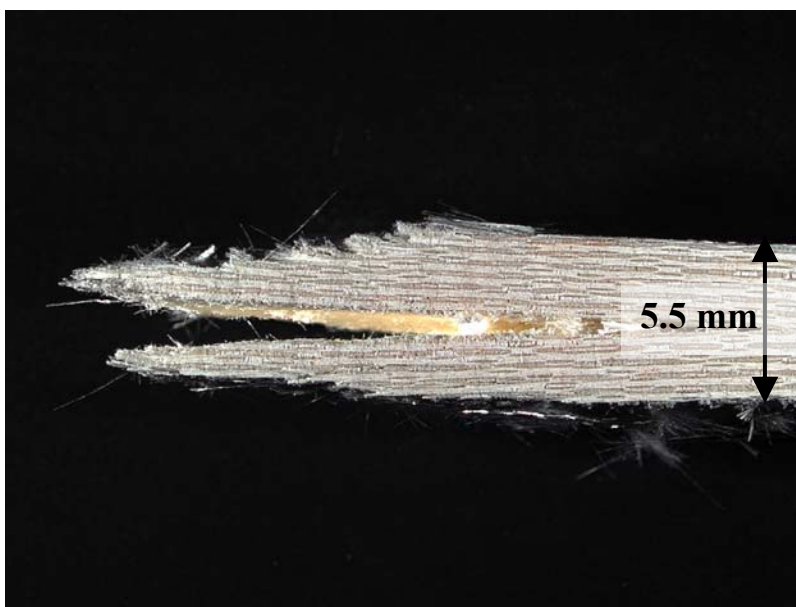
Figure 234. Fracture surface of N720/A specimen tested in compression to failure in air at 1200°C in stress control at -0.0025 MPa/s.

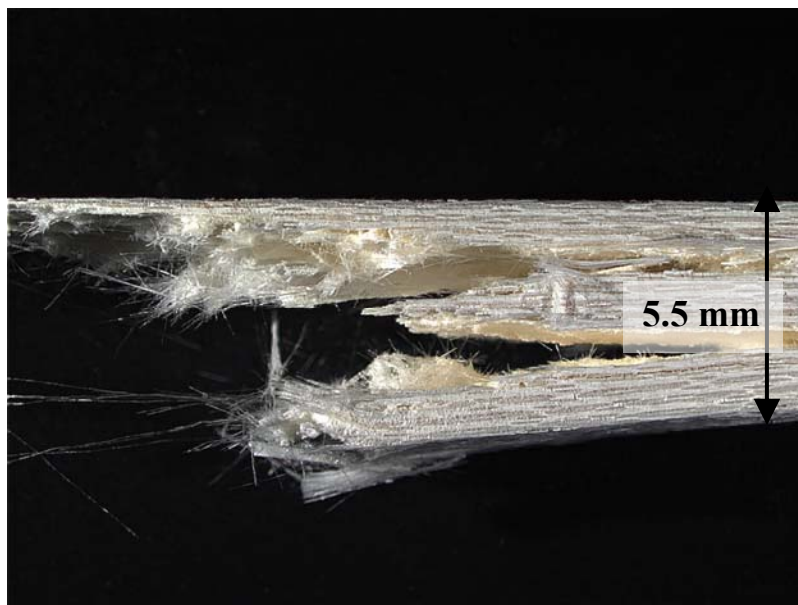
Figure 236. Fracture surface of N720/A specimen tested in compression to failure in air at 1200°C in stress control at -0.0025 MPa/s.

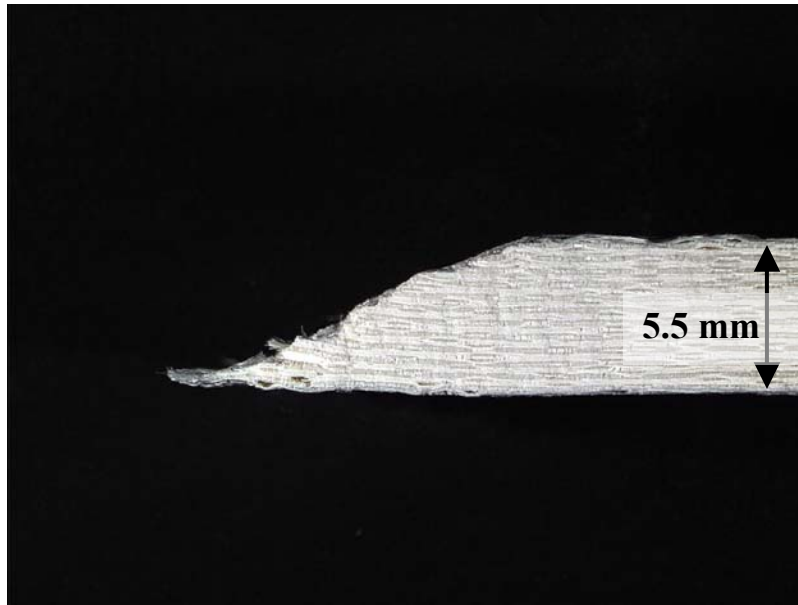
Figure 237. Fracture surface of N720/A specimen tested in compression to failure in steam at 1200°C in stress control at -0.0025 MPa/s.

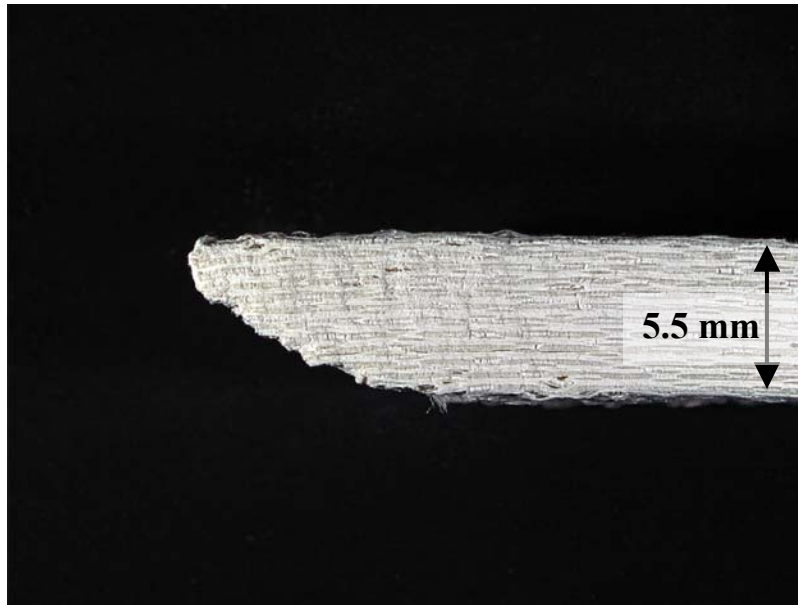
Figure 239. Fracture surface of N720/A specimen tested in compression to failure in steam at 1200°C in stress control at -0.0025 MPa/s.

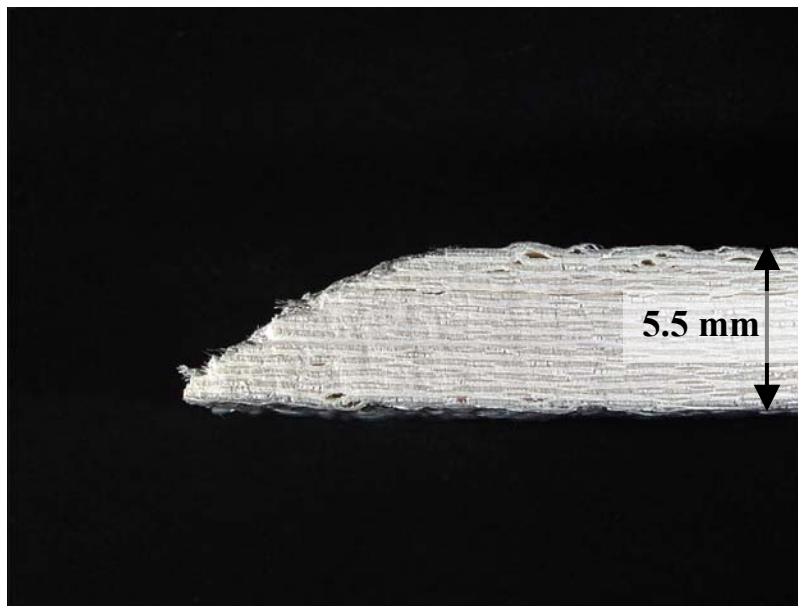
Figure 240. Fracture surface of N720/A specimen tested in compression to failure in steam at 1200°C in stress control at -0.0025 MPa/s.

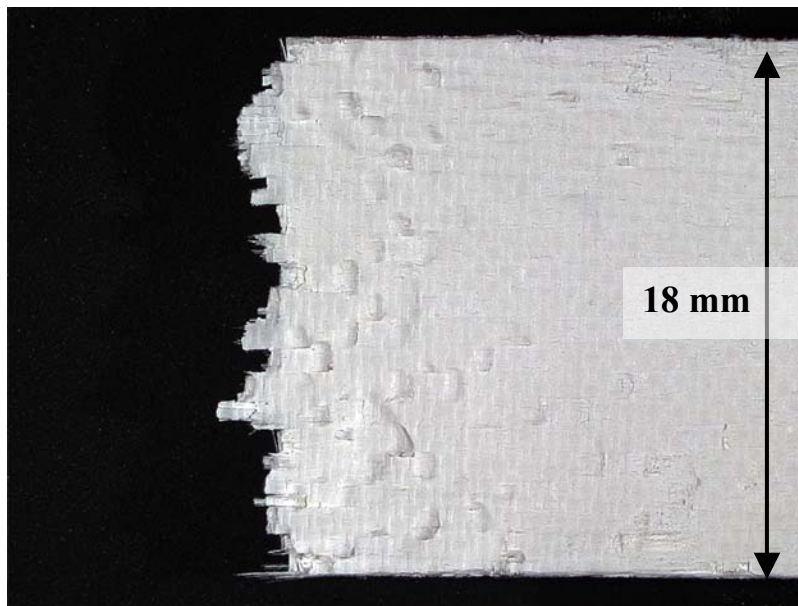
Figure 242. Fracture surface of N720/A specimen tested in compression to failure in steam at 1200°C in stress control at -0.0025 MPa/s.

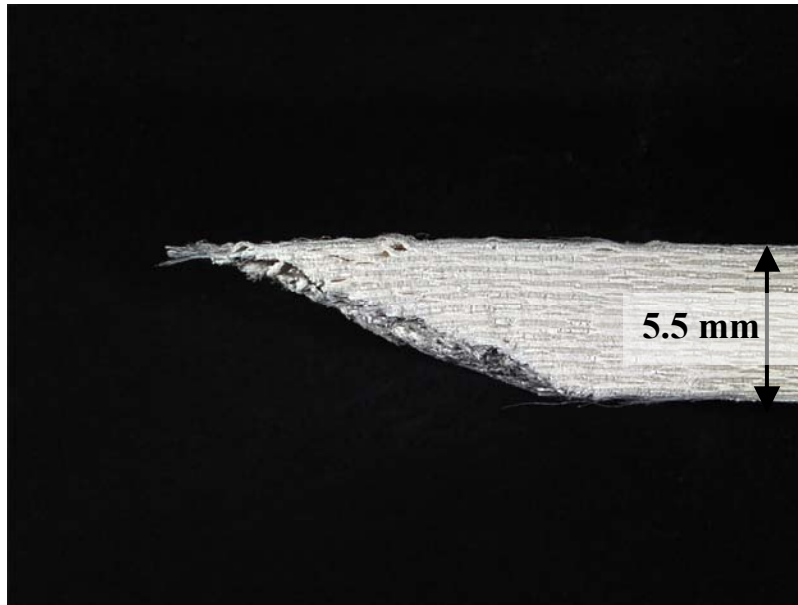
Figure 243. Fracture surface of N720/A specimen tested in compression to failure in steam at 1200°C in stress control at -0.0025 MPa/s.
